METALS HANDBOOK

VOL. 9
FRACTOGRAPHY AND ATLAS OF FRACTOGRAPHY

8th EDITION

Fractography and Atlas of Fractographs

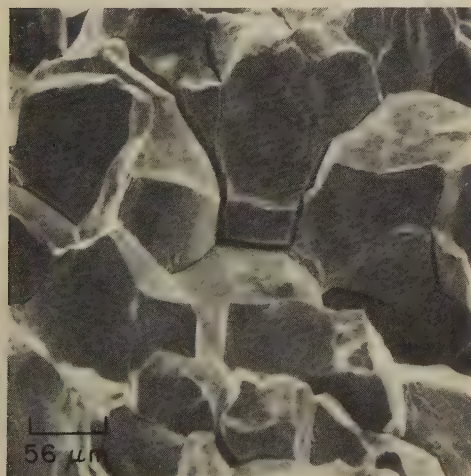
SEM fractograph 180×

Fig. 41. Intergranular corrosion fracture near a circumferential weld in a thick-wall tube made of type 304 stainless steel. The heat-affected zone of the weld was sensitized by the temperature of welding, and consequently it was susceptible to intergranular attack. Note the smooth grain facets and the secondary cracks at the grain boundaries.

Figure 41 shows an intergranular fracture that developed near a circumferential weld in a thick-wall tube of type 304 stainless steel. Such fractures develop with or without applied stress and are considered a result of intergranular corrosion. Steels in the sensitized condition (where exposure to elevated temperatures can cause carbide precipitation at the grain boundaries and subsequent chromium depletion nearby) are particularly susceptible to intergranular cracking and fracture. For the tube in Fig. 41, high welding temperature caused the heat-affected zone to become sensitized. The grain facets are smooth and show only limited slip deformation. Secondary cracking has occurred around some grains. There is no visible evidence of carbide precipitation.

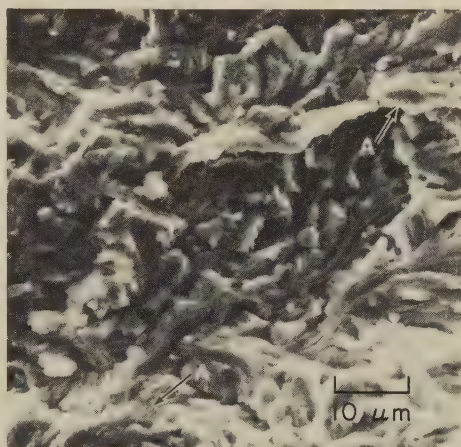
SEM fractograph 1000×

Fig. 42. Transgranular stress-corrosion fracture in condenser tubing of copper alloy CDA No. 687 (aluminum brass, arsenical). Fracture originated on the inside surface of the tube and propagated radially. The two subgrain regions indicated by A's display striations of various orientations.

sustained tensile stress and the action of ammonia in the presence of moisture and oxygen. Figure 42 shows a very irregular transgranular fracture surface generated in condenser tubing of annealed copper alloy CDA No. 687 (aluminum brass, arsenical). The fracture was initiated at the inside surface of the tube and propagated radially. Although the over-all fracture plane in the central portion of the fractograph is flat, the fracture surface is composed of a large number of small regions that are inclined at random angles and contain short, fine striations. These regions are of subgrain size and probably

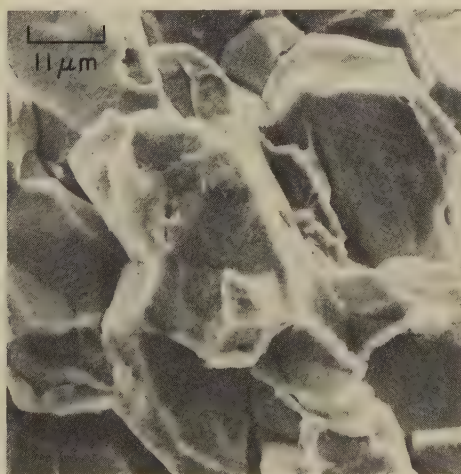
SEM fractograph 900×

Fig. 43. Intergranular fracture in tubing made of nickel-copper alloy Monel 400, after exposure to high-temperature high-pressure steam. Secondary cracks are also intergranular. There is no grain-boundary deformation. The grainy appearance of grain facets suggests corrosion.

Nickel-copper alloy Monel 400, which is highly resistant to stress-corrosion cracking in both the annealed and the cold worked states, has been observed to fracture, on rare occasions, in an intergranular fashion when exposed to high-temperature high-pressure steam. A fracture that occurred in Monel 400 steam-line tubing is shown in Fig. 43. The grains show no evidence of grain-boundary deformation, but their grainy surfaces suggest mild corrosion. The fracture is entirely intergranular.

Accelerated laboratory generation of fractures of the type shown in Fig. 43 in specimens of Monel 400 always requires high stress levels and an environment of ammonium hydroxide or hydrazine. The possibility that corrosion fatigue is responsible for this service fracture must, therefore, be considered. Monel 400 has been shown to exhibit decidedly intergranular fractures when fatigue tested at maximum strains near the yield point. Figures 44 and 45 show fracture surfaces from laboratory fatigue tests of Monel 400 generated in fully reversed bending. In Fig. 44, the fracture mechanism is

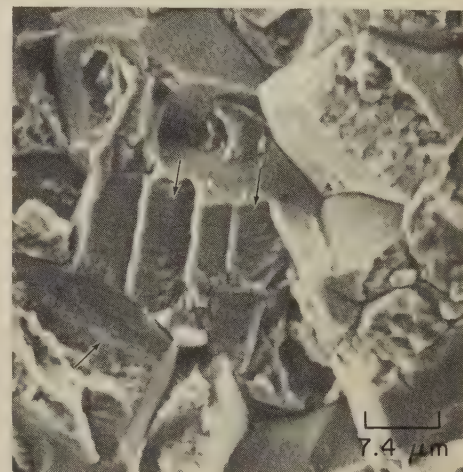
SEM fractograph 1350×

Fig. 44. Mixed intergranular-transgranular fracture in a specimen of Monel 400 that resulted from room-temperature, fully reversed-bending fatigue. Specimen was tested in air. Many of the regions of transgranular fracture show fatigue striations (see arrows) produced by the plastic flow that took place at the crack tip as it cyclically opened and closed.

Fatigue-striation formation plus intergranular fracture is the cyclic-loading analog of intergranular fracture plus either tearing or microvoid coalescence. It typically occurs in metals that have incompletely developed preferred fracture paths at the grain boundaries. In such metals, intergranular fracture occurs in the regions that have a preferred grain-boundary fracture path. The remaining regions cannot readily fracture intergranularly; they fracture in fatigue and exhibit the usual striations associated with transgranular fatigue cracking. This type of fracture occurs much less frequently than the other mixed mechanisms. However, Fig. 44 and 45 show both fatigue striations and separated-grain facets in Monel 400.

mixed intergranular-transgranular, with some of the transgranular portions of the fracture exhibiting fatigue striations associated with the plastic flow occurring with the cyclic opening and closing of the crack tip. In Fig. 45, where the fracture is totally intergranular, evidence of the cyclic nature of the cracking can be seen in the fatigue striations on the separated-grain facets. The mechanism by which striations are formed on separated-grain

facets is not understood, but it may be associated with the closing together of the crack surfaces during the compression portion of the bending cycle. In both Fig. 44 and 45, the fracture surfaces have a different appearance than the corroded surface of the service fracture in Fig. 43.

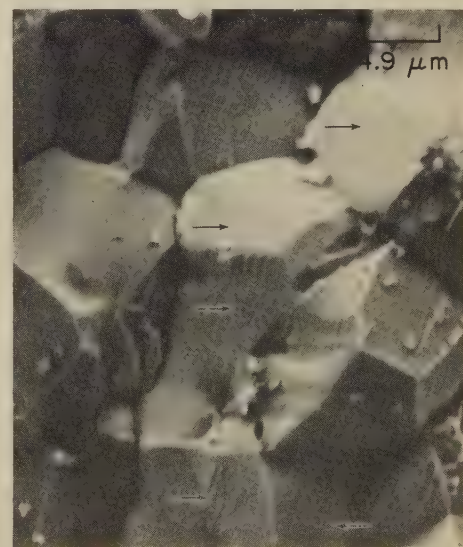
SEM fractograph 2050×

Fig. 45. Reversed-bending fatigue fracture in a specimen of Monel 400, showing fatigue striations on separated-grain facets (see arrows). The way in which the striations formed is not understood. If it is assumed that they were produced during the closing of the crack surfaces in the compression half of the bending cycle, they might be likened to tire tracks.

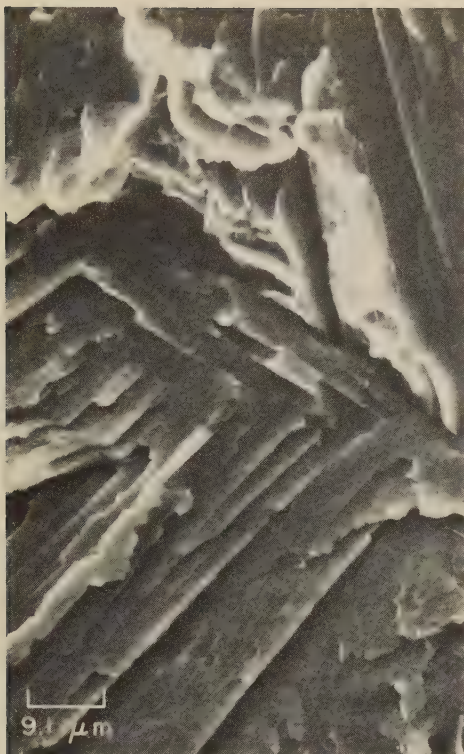
SEM fractograph

1100×

Crack propagation was by transgranular cleavage through the alpha and beta phases. Fissures normal to the cleavage plane formed at alpha-beta interfaces to produce the layered structure.

Fig. 46. Stress-corrosion cracking in titanium alloy Ti-7Al-2Cb-1Ta due to exposure to a solution of 3½% NaCl in water

The fracture surface generated in titanium alloy Ti-7Al-2Cb-1Ta exposed to a solution of 3½% NaCl in water is shown in Fig. 46. In the area shown, the cracking mechanism was transgranular cleavage. The cleavage crack propagated across a mixed alpha-beta microstructure. The layered surface resulted because some splitting occurred normal to the cleavage plane at the alpha-beta interfaces. An identical fracture topography results in this alloy when the environmental medium is liquid mercury, the only difference being in the orientation of the principal fracture plane relative to the hexagonal unit cell of the alpha titanium. Cracking resulting from mercury attack is parallel to the basal plane; that resulting from salt-water attack is inclined to the basal plane at a small angle.

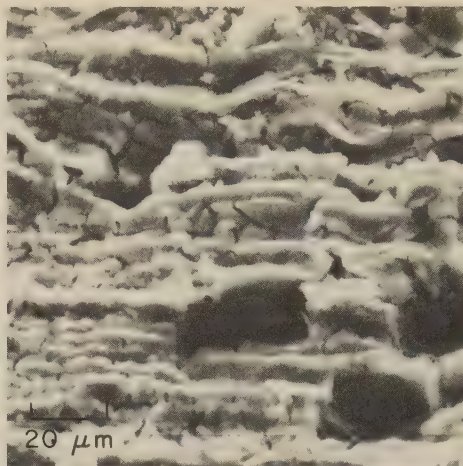
SEM fractograph

500×

Fig. 47. Corrosion products on a stress-corrosion fracture in cold worked type 201 stainless steel. The ridges present here correspond to bands in the microstructure. The layer of corrosion products makes it impossible to determine the mechanism of fracture.

Corrosion on Fracture Surfaces. Fractography of service fractures is hampered when the materials that fracture are exposed to corrosive environments before analysis of the fracture surface can be carried out, and the fine detail of the fracturing process is obliterated. Figure 47 shows a fracture surface in cold worked type 201 stainless steel that fractured in an environment that severely corroded the steel. The parallel ridges in the fractograph correspond to the banded condition of the microstructure. The "mudcake" corrosion products covering the surface, together with the corrosion pits, prevent positive identification of the operative fracture mechanism.

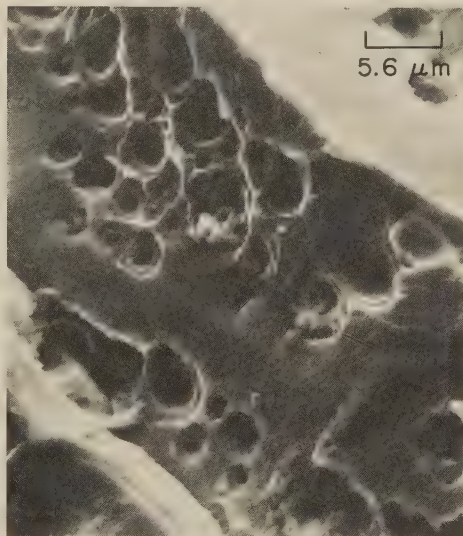
SEM fractograph

1800×

Fig. 48. Corrosion pitting on grain-boundary facets of intergranular stress-corrosion cracks in copper alloy CDA No. 360 (free-cutting, leaded brass). Corrosive attack was assumed to have resulted from galvanic action between the brass matrix and the lead precipitate (see text).

Figure 48 shows the corrosion pitting of intergranular facets that occurred in leaded copper alloy CDA No. 360 (free-cutting brass) fractured by stress-corrosion cracking. Using an energy-dispersive x-ray detector, the flocculent material within the corrosion pits was determined to be lead. Corrosion was assumed to have resulted from the galvanic action between the brass matrix and the lead precipitate exposed to the corrodent by the stress-corrosion crack.

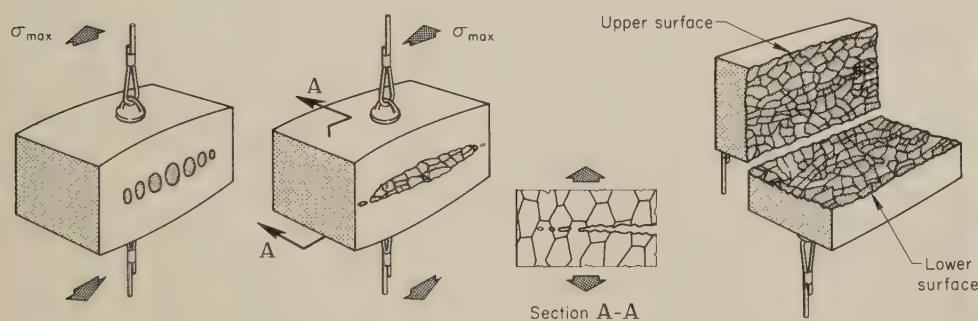
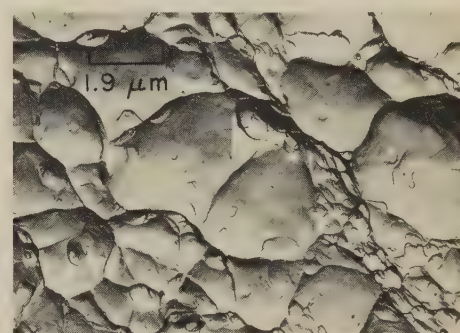
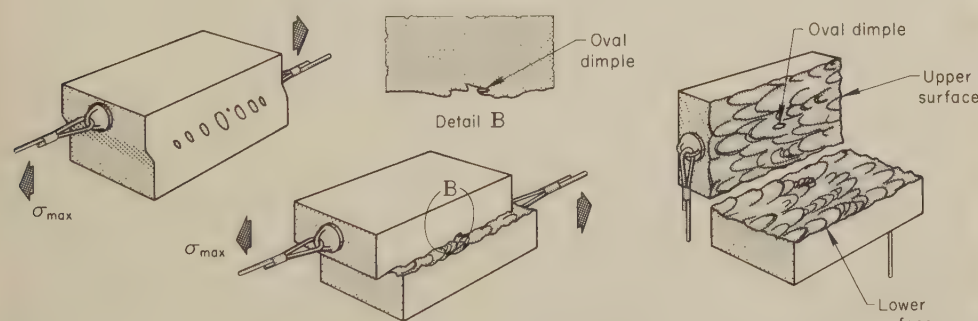
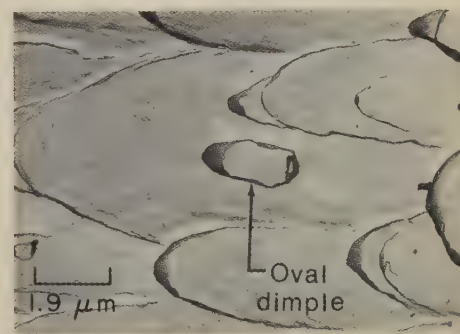
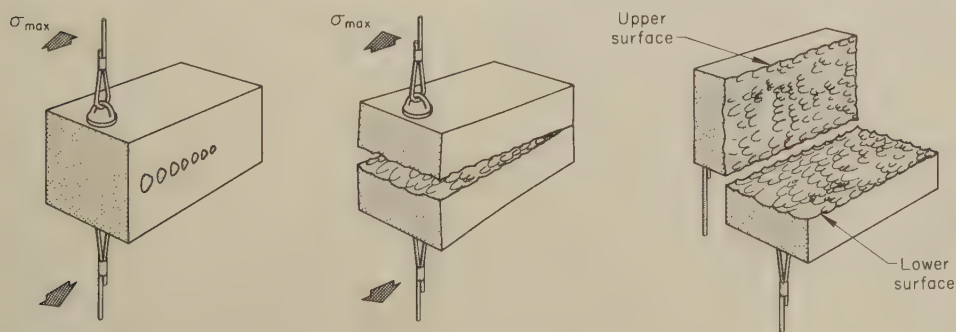
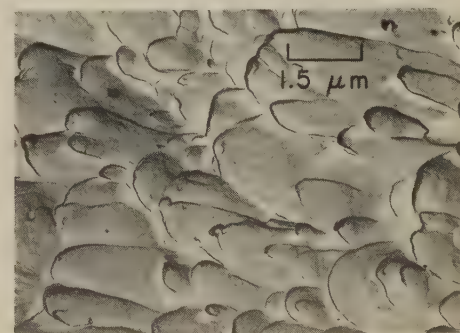
(a) Equiaxed dimple (tension)

(b) Elongated dimple (shear)

(c) Elongated dimple (tensile tearing)

Fractographs show shapes of dimples formed. (a) In tension, equiaxed dimples are formed on both fracture surfaces. (b) In shear, elongated dimples

point in opposite directions on matching fracture surfaces. (c) In tensile tearing, elongated dimples point toward fracture origin on matching fracture surfaces.

Fig. 1. Influence of direction of maximum stress (σ_{max}) on the shape of dimples formed by microvoid coalescence

The shape of a dimple is influenced by the relative stress directions operating to make the microvoid grow, as shown in Fig. 1. When the fracture is caused by simple tension, dimples usually have an equiaxed appearance, as shown in Fig. 1(a). When a shearing motion takes place, as in a shear-lip or torsion fracture, the dimples have an elongated, parabolic shape, and the dimples on opposing fracture surfaces point in opposite directions (Fig. 1b). A fracture that takes place by tensile tearing also produces elongated dimples, but the dimples on opposing fracture surfaces point in the same direction (toward the fracture origin), as shown in Fig. 1(c). Occasionally, oval dimples form in the flatter, more highly stretched portions of elongated dimples, as the result of the breaking open of small subsurface microvoids that intersect the surface of existing microvoids (see Ref 2, Fig. 1b and Fig. 2).

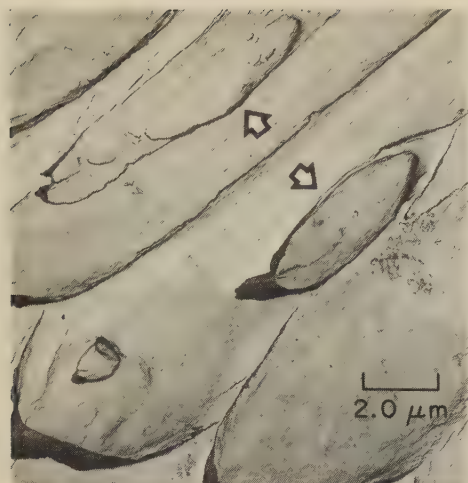
TEM fractograph (p-c replica) 4900×
Fig. 2. Oval dimples (at arrows) that formed in flatter, more highly stretched portions of elongated dimples on a fracture surface of titanium alloy Ti-6Al-4V

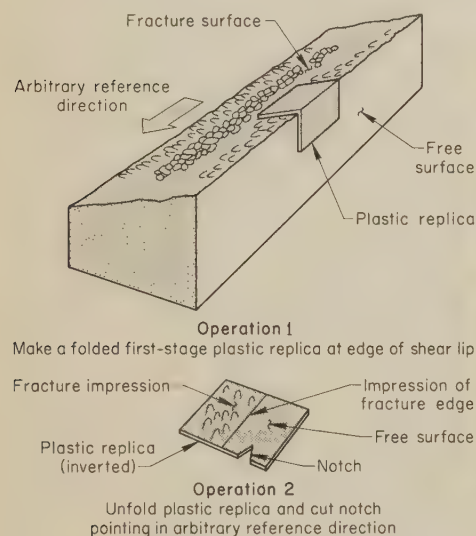
Fig. 3. Schematic representation of a replication technique that permits positive identification of the direction of shear fracture from the orientation of "open" elongated dimples on the acute-angle edge of a shear lip

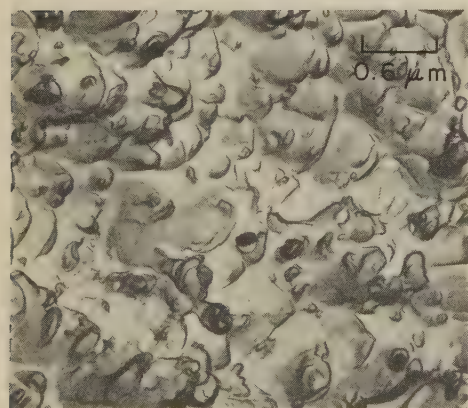
TEM fractograph (p-c replica) 18,200×
Fig. 4. Small dimples that formed at nucleation sites provided by dispersed particles of ThO₂ on a fracture surface of TDNi (thoriated nickel). The particles are at the apexes of the dimples.

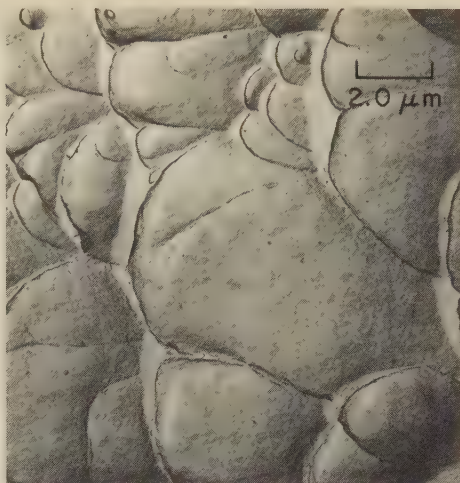
TEM fractograph (p-c replica) 4900×
Fig. 5. Large, elongated dimples on a fracture surface of titanium alloy Ti-6Al-4V. There were relatively few nucleation sites for microvoids.

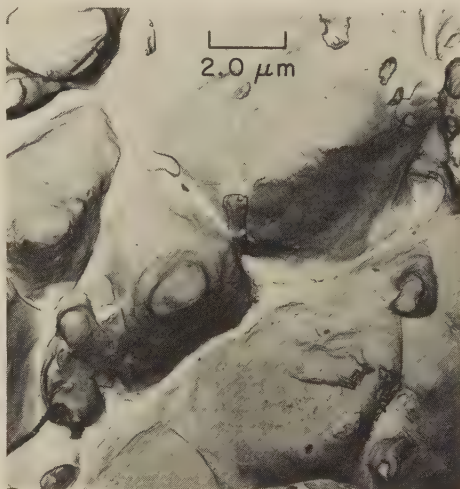
TEM fractograph (p-c replica) 4900×
Fig. 6. Deep, conical dimples on a fracture surface of ductile 1018 steel

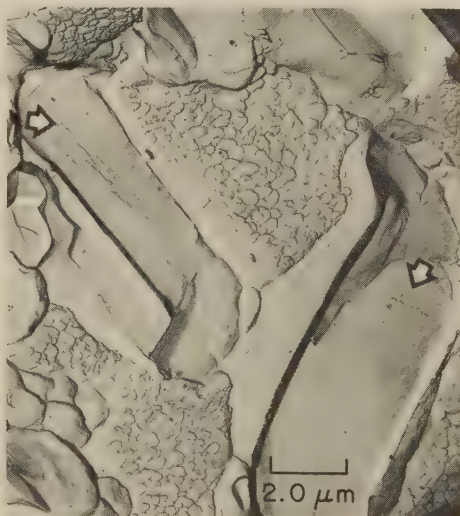
TEM fractograph (p-c replica) 4900×
Fig. 7. Fracture of large second-phase particles (at arrows) in the matrix of cast aluminum alloy 356-T6. Matrix dimple size was not affected by the mechanism that caused fracture of the particles.

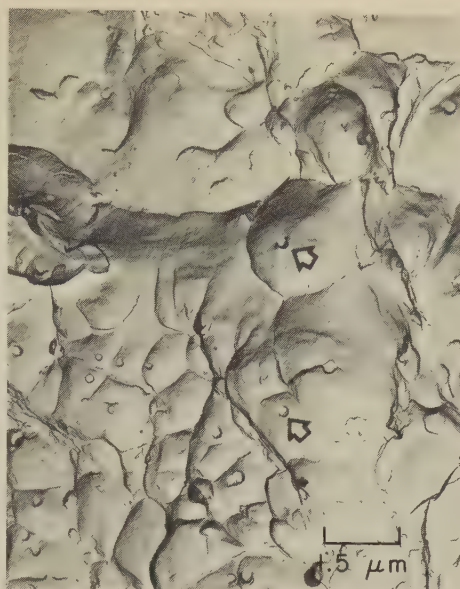
TEM fractograph (p-c replica) 6500×
Fig. 8. Small, second-phase particles (at arrows) that acted as microvoid-initiation sites and strongly influenced the shape of dimples on a fracture surface of 17-4 PH stainless steel

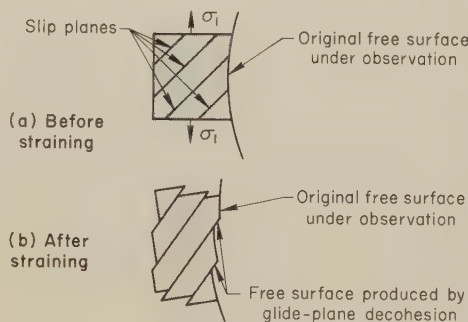
Fig. 9. Simple model for fracture by glide by a slip process (σ_1 = tensile stress caused by straining). Glide by twinning may also produce new free surfaces.

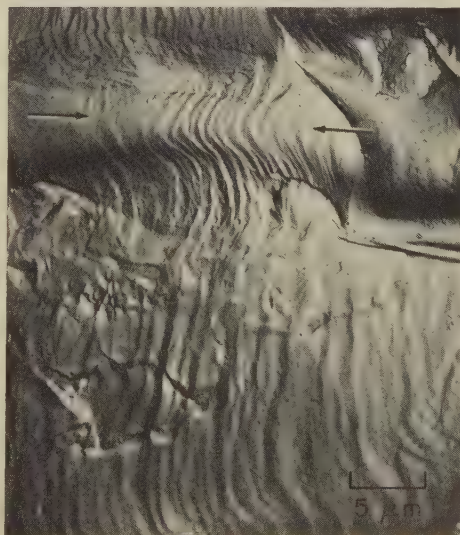
TEM fractograph (p-c replica) 2000×
Fig. 10. Serpentine glide on a fracture surface of Armco iron. Distinct slip steps, produced by glide-plane decohesion, may be seen between the arrows. Replica was palladium shadowed.

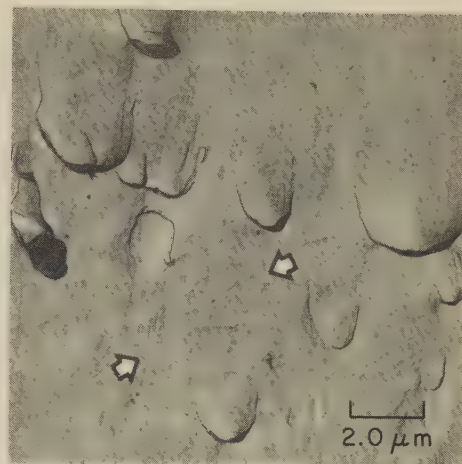
TEM fractograph (p-c replica) 4900×
Fig. 11. Ripples (between arrows) on a dimpled fracture surface of type 302 stainless steel

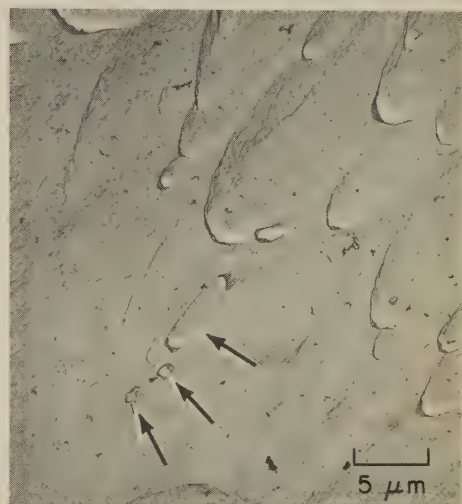
TEM fractograph (direct carbon replica) 2000×
Fig. 12. Stretched regions, shear dimples, and three oval tear dimples (at arrows) on a fracture surface of type 304 stainless steel. Replica was palladium shadowed.

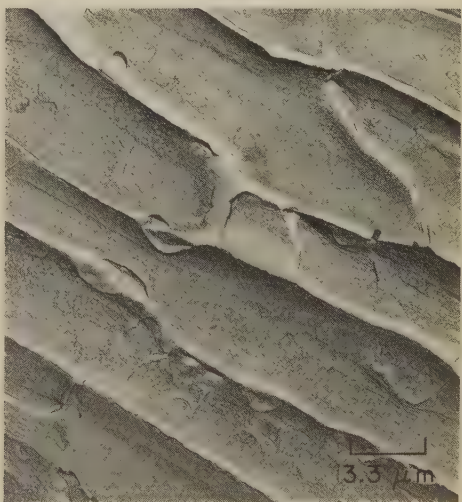
TEM fractograph (p-c replica) 3000×
Fig. 13. Troughs formed in a fracture surface of beta-annealed titanium alloy Ti-8Al-2Cu-1Ta by nucleation, growth and coalescence of linear microvoids during fast fracture

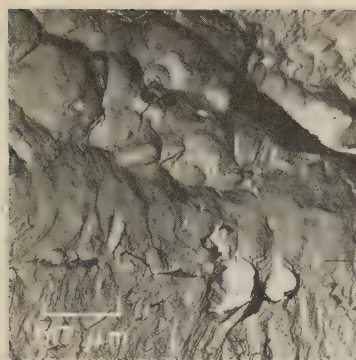
Rapid fracture
↓
Stretched zone
↓
Fatigue

TEM fractograph (p-c replica) 1750×
Fig. 14. Stretched zone in a fracture surface of a fracture-toughness specimen of 0.600-in.-thick plate of 18% Ni, grade 200, maraging steel tested at -196°C (-321°F).
 $K_{Ic} = 69.1 \text{ MPa}\cdot\text{m}^{1/2}$ ($62.9 \text{ ksi}\cdot\text{in.}^{1/2}$).

Some investigators (Ref 1, 5, 6) have related the size of the stretched zones that appear in fractures of fatigue-pre-cracked fracture-toughness specimens to the critical plane-strain stress-intensity factor, K_{Ic} . The stretched zone occurs at the root of the fatigue precrack, and it is postulated that the extent of the stretched zone is a function of the amount of localized plastic flow at the crack tip before the onset of rapid crack propagation (see Fig. 14 and 15).

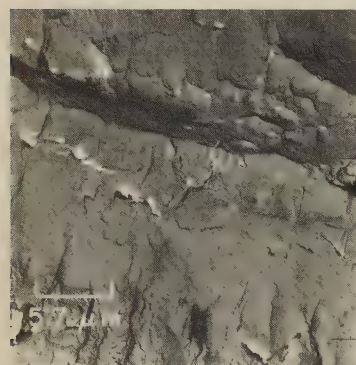
Rapid fracture
↓
Stretched zone
↓
Fatigue

TEM fractograph (p-c replica) 1750×
Fig. 15. Stretched zone in a fracture surface of a fracture-toughness specimen of 0.300-in.-thick plate of 18% Ni, grade 200, maraging steel tested at -196°C (-321°F).
 $K_{Ic} = 139.5 \text{ MPa}\cdot\text{m}^{1/2}$ ($127 \text{ ksi}\cdot\text{in.}^{1/2}$).

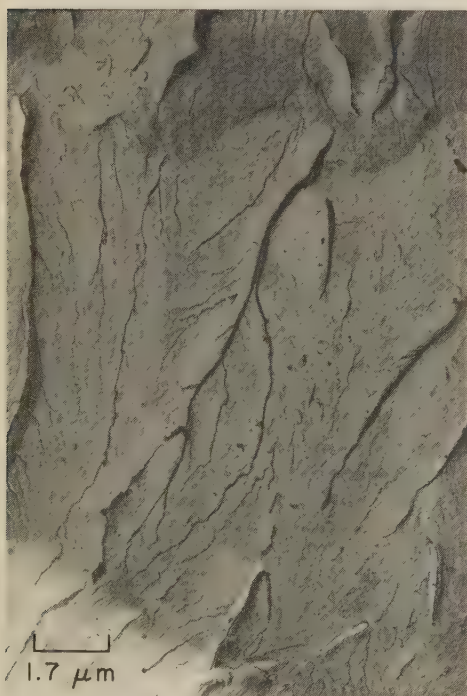
TEM fractograph (p-c replica) 6000×
Fig. 16. Cleavage fracture in a low-carbon steel with a tensile strength of about 415 MPa (60 ksi); an unusual fracture for a ductile metal of this sort. See Fig. 17 for microstructure of the steel.

Cleavage describes a fracture mechanism; it may not be indicative of the relative ductility of a material. For example, the fracture surface of beryllium consists primarily of cleavage facets even when the metal has undergone 20% elongation before fracture. Cleavage can also occur in a low-carbon steel with a tensile strength of about 415 MPa (60 ksi), even though it may be quite ductile and should display fracture by micro-

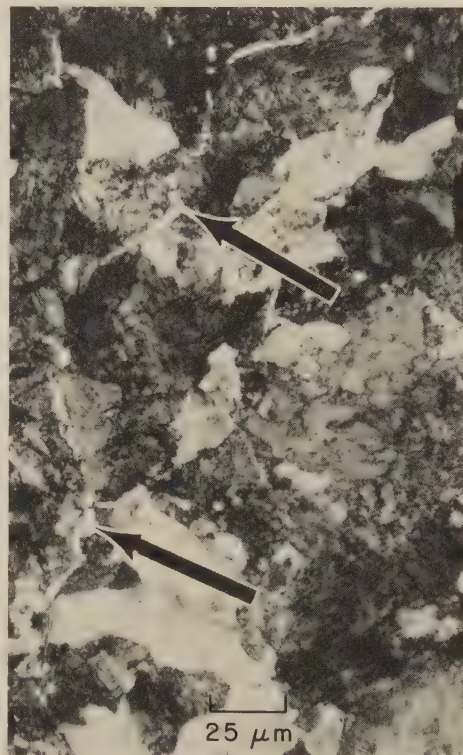
Micrograph (etchant: nital) 400×
Fig. 17. Microstructure of the low-carbon steel for which a cleavage fracture is shown in Fig. 16. Grain-boundary network of free ferrite (at arrows) is believed to be responsible for the cleavage fracture.

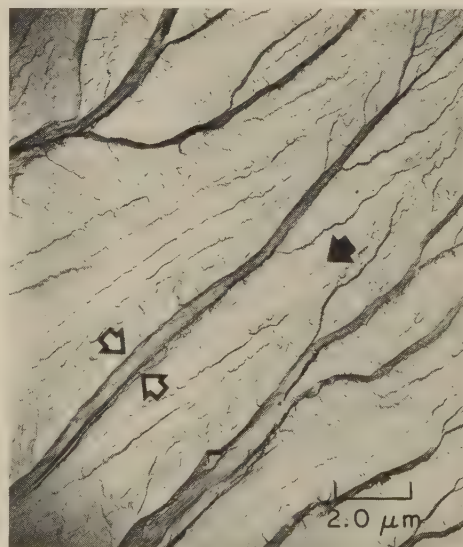
TEM fractograph (p-c replica) 4900×
Fig. 18. River patterns on a fracture surface of an Alnico alloy specimen. The white arrows point to a cleavage step; the black arrow shows the direction of crack propagation.

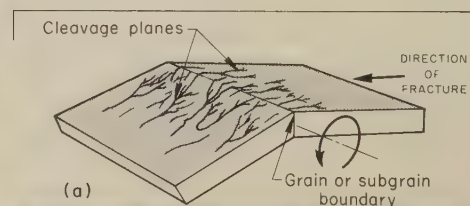
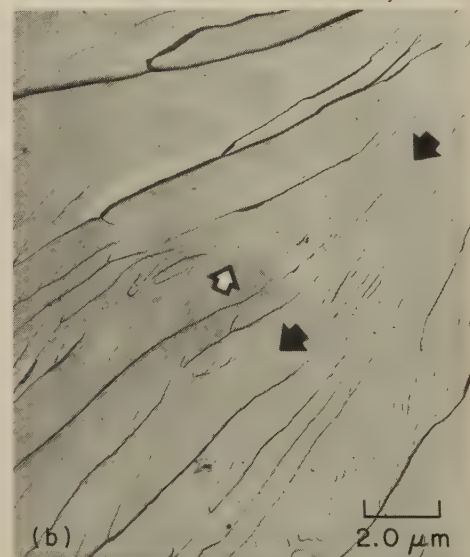
TEM fractograph (p-c replica) 4900×
(a) Fracture model showing fracture direction, cleavage planes and low-angle grain or subgrain boundary. (b) Low-angle tilt boundary in a fracture surface of columbium alloy B-66 (5% Mo, 5% V, 1% Zr). Black arrows show fracture direction; white arrow shows a tilt boundary.

Fig. 19. Effect of low-angle tilt boundary on cleavage-crack propagation

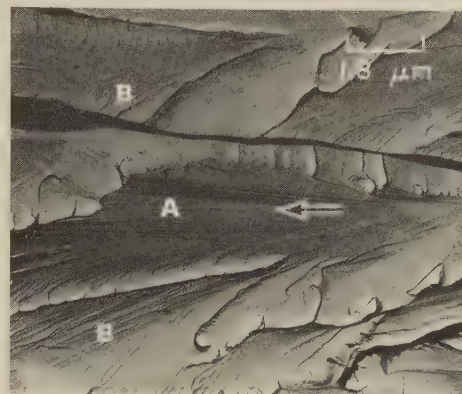
TEM fractograph (p-c replica) 5500X
Fig. 21. Cleavage feather marks (at A) on a fracture surface of unalloyed tungsten. The decorations at B resemble very fine river patterns, rather than feathers. Arrow shows fracture direction.

Another distinct cleavage-fracture feature is called "feather marks" (Fig. 20, 21). Feather marks have an appearance similar to chevron patterns in that they usually point back in the direction of local crack origin. It should be noted that the ability to distinguish fracture direction on cleavage surfaces of specific grains may not help in determining the macroscopic fracture direction. Cleavage fracture may take place by very local separation ahead of the moving crack front. Local crack-growth direction is highly dependent on crystallographic orientation. It may be totally unrelated to the macroscopic crack-growth direction, but it still may be used to find the fracture origin. (See the section on Fractographic Mapping To Identify Fracture Origins on page 44 in the article on Interpretation of Light-Microscope Fractographs.)

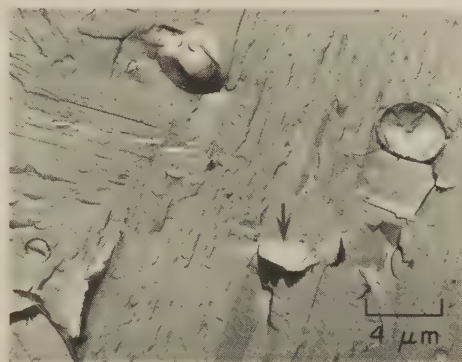
TEM fractograph (p-c replica) 2500X
Fig. 22. Cleavage tongues, such as at arrow, which formed along twin-matrix interfaces in Armco iron fractured at dry-ice temperature

Cleavage tongues (Fig. 22) have been observed on some materials. This feature is ascribed to the local deviation of a cleavage-plane crack as it intersects a boundary between a deformation twin and the matrix. The twin-surface projection (tongue) corresponds to a matching depression in the mating fracture surface (Ref 7). Another feature of cleavage fracture is herringbone pattern, which is shown in Fig. 23. This fracture feature has been observed principally in body-centered-cubic materials and is related to cleavage of the {100} plane fracturing in the <100> direction at the center of the herringbone. The herringbones on either side are related to {100} planes fracturing in the <110> direction and along {112}<110> twin interfaces. Both cleavage tongues

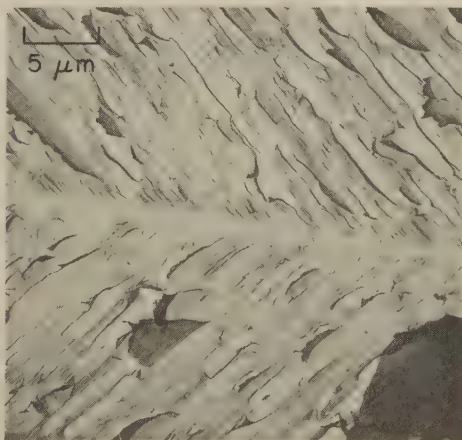
Fig. 23. Herringbone pattern on a fracture surface of an Fe-Cr-Al alloy

TEM fractograph (p-c replica) 2000X
Cleavage occurred along the central strip on a {100} plane in a <100> direction. On either side, the herringbone marks resulted from fracture on {100} planes in <110> directions and along {112}<110> twin interfaces.

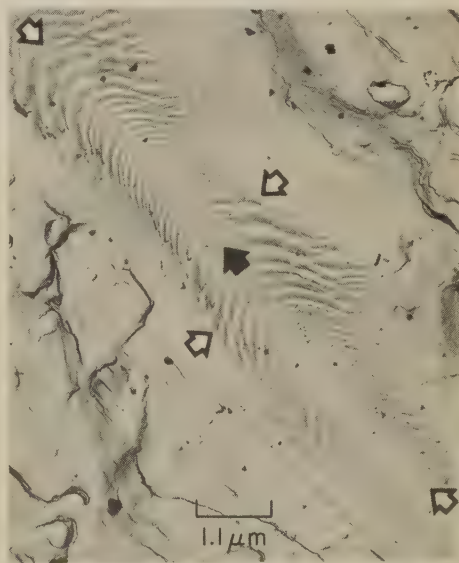
Fig. 24. Wallner lines (between white arrows) on a fracture surface of an aluminum alloy A356-T6 casting

TEM fractograph (p-c replica) 9000X
Black arrow indicates the direction of fracture propagation. Note that the Wallner lines cross each other, a circumstance that differentiates Wallner lines from fatigue striations.

Many engineering metals contain brittle, intermetallic second-phase particles. Occasionally, marks known as Wallner lines appear on these brittle phases (Fig. 24). This feature is assumed to result from the interaction of a propagating crack front and elastic stress waves in the material. Wallner lines appear as parallel cleavage steps, creating a rippled pattern. They can be observed to cross each other and are distinguishable from fatigue striations, which never cross each other.

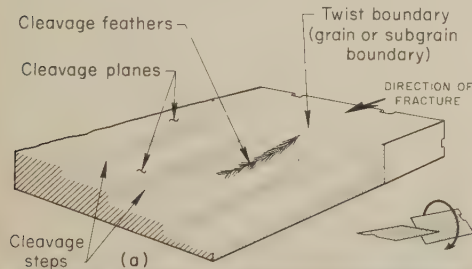
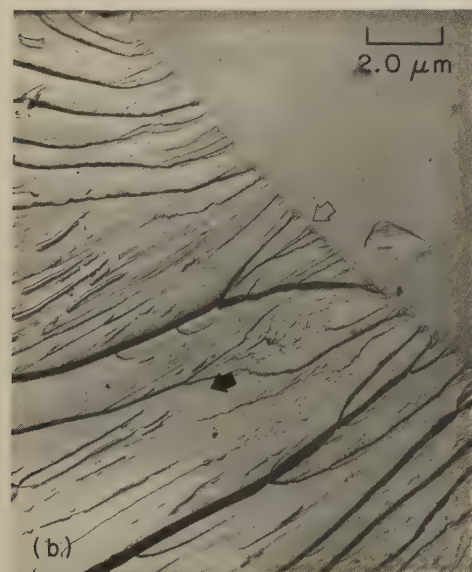
Fig. 20. Effect of twist boundary on cleavage decoration

TEM fractograph (p-c replica) 4900X
(a) Fracture models showing a twist boundary and the new cleavage steps that develop as the propagating crack crosses a twist boundary. (b) Cleavage steps initiating at a twist boundary (open arrow) on a fracture surface of columbium alloy B-66 (5% Mo, 5% V, 1% Zr). Solid black arrow indicates fracture direction. Feather marks exist between steps.

If an adjacent grain or subgrain is axially misoriented relative to the local fracture direction, the boundary of that grain is a twist boundary. New cleavage steps will form when the propagating crack crosses the twist boundary (Fig. 20).

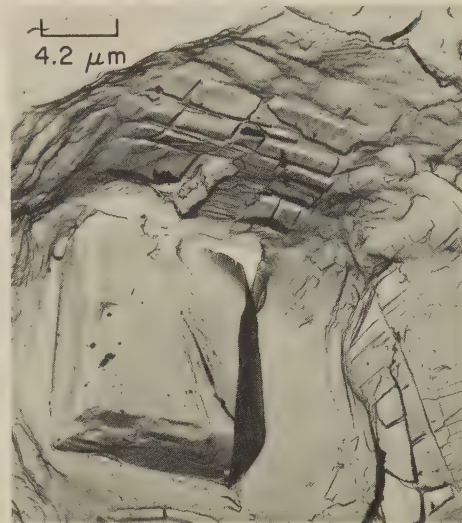
TEM fractograph (p-c replica) 2400×
Fig. 27. Cleavage in a large second-phase particle on a fracture surface of A-286 steel

- 1 Fracture by quasicleavage appears to be initiated within facet boundaries. This is in contrast to fracture by cleavage, which is usually initiated from one edge of the region being cleaved (Fig. 27).
- 2 Cleavage steps in quasicleavage appear to blend directly into tear ridges of the adjacent dimpled areas.

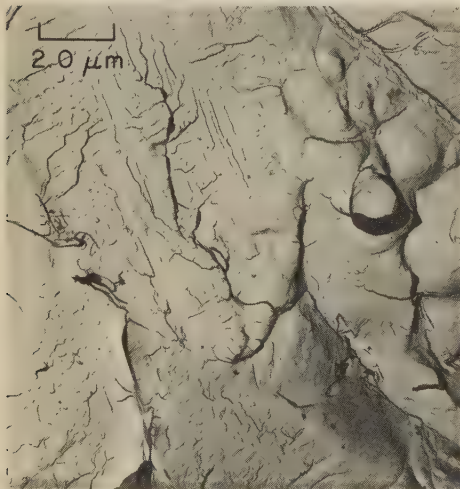
TEM fractograph (p-c replica) 4900×
Fig. 25. Effect of quasicleavage—mixed cleavage and microvoid coalescence—on the fracture-surface appearance of 17-4 PH stainless steel

dimples of microvoid coalescence appearing in the more ductile matrix. In quasicleavage, there is no apparent boundary between a cleavage facet and a dimpled area bordering the cleavage facet (Fig. 25). A schematic representation of quasicleavage is given in Fig. 26.

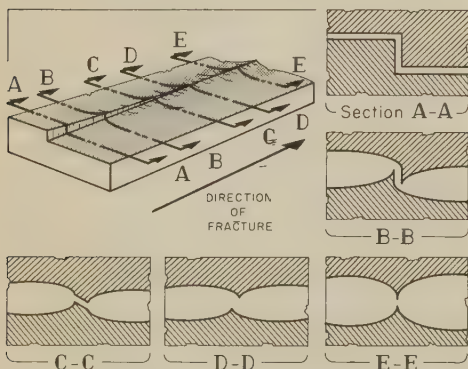
Fig. 26. Fracture model showing a cleavage step blending in with a tear ridge in a quasicleavage fracture surface

At the top left is the lower surface of a fracture, showing a step at the lower left and a ridge at the upper right. At right and at bottom are sections through the fractured member, showing profiles of both the upper and the lower fracture surfaces.

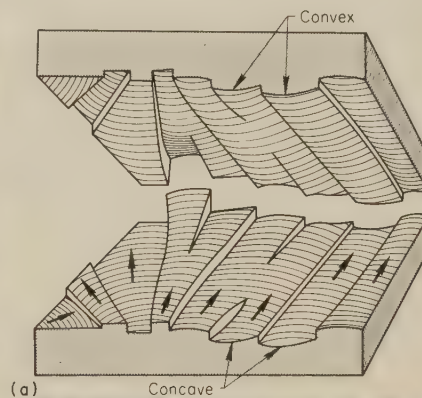
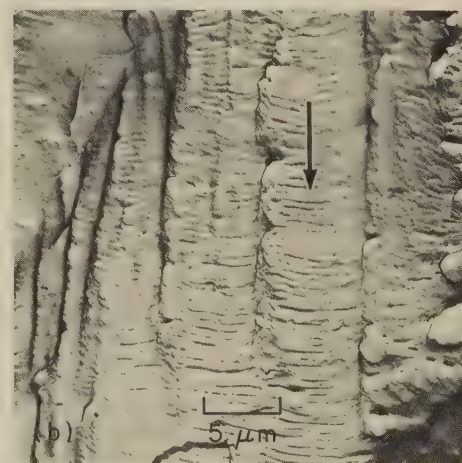
Fig. 28. Fracture model and fractograph of fatigue striations

TEM fractograph (p-c replica) 2000×
(a) Fracture model of fatigue striations, showing striation plateaus and tear ridges. Arrows indicate the directions of crack propagation.
(b) Fatigue striations on a fracture surface of a 5-in.-thick plate of aluminum alloy 2024-T851. Arrow indicates the direction of crack propagation.

crack initiation and growth. Fortunately, the part of the fatigue process that entails crack growth leaves clear fractographic evidence, commonly known as fatigue striations (Fig. 28). It has been shown by several investigators that each fatigue striation is the result of a single stress cycle. The corollary of this statement is not necessarily true—a stress cycle does not always produce a striation. Fatigue striations differ in appearance (or may not occur), depending on environmental effects, the relative ductility of the metal, the stress level propagating the crack, and the stress state.

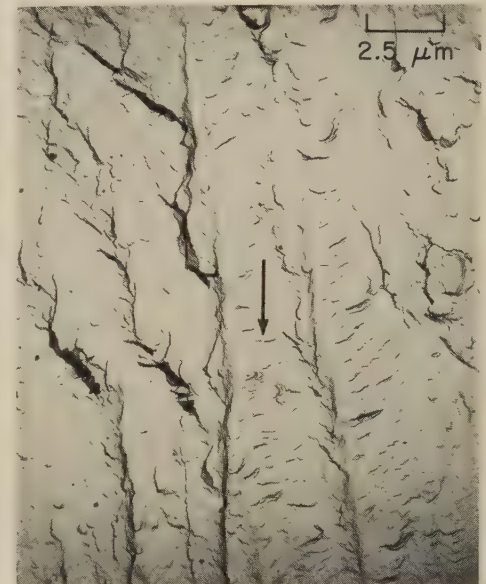
TEM fractograph (p-c replica) 4000×
Fig. 29. Stage I of fatigue-fracture progress in aluminum alloy 2024-T4. Fracture surface resembles cleavage; it does not have fatigue striations. Arrow indicates direction of crack propagation.

The initial portion of fatigue-fracture progress, which has been termed stage I cracking, is generally attributed to slip-plane fracture from repetitive reversing of the operative slip system in the metal. There are usually no fatigue striations associated with stage I cracking. In fact, the fracture has the appearance of cleavage, with little or no evidence of plastic behavior (see Fig. 29). The area of stage I of fatigue cracking is usually very small (frequently two to five grains deep); in some instances (depending on the material, environment, and stress level), it may not be discernible. Stage II of fatigue-fracture progress begins with the formation of characteristic striations, described in the following paragraphs.

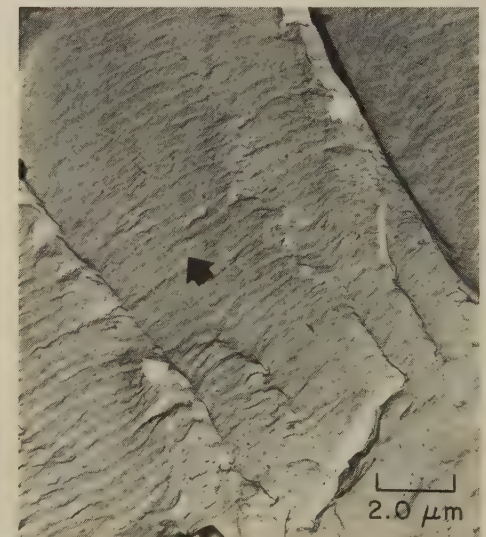
Fig. 30. High-cycle fatigue striations in a fracture surface of aluminum alloy 6061-T6

TEM fractograph (p-c replica) 4900×
The striations are closely spaced and propagate on flat plateaus joined by shear steps (at white arrows). Black arrow indicates direction of crack propagation.

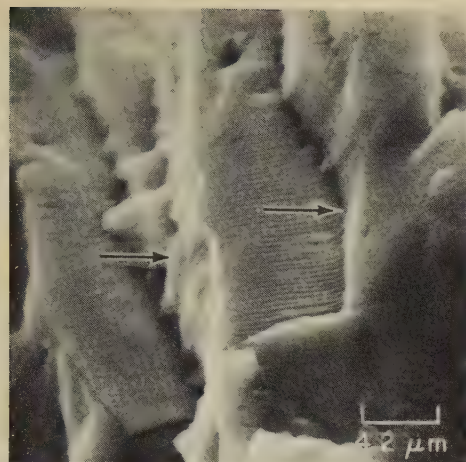
SEM fractograph 2400×
Fig. 31. Striation plateaus and shear steps (at arrows) in a fatigue fracture in aluminum alloy 2219-T87

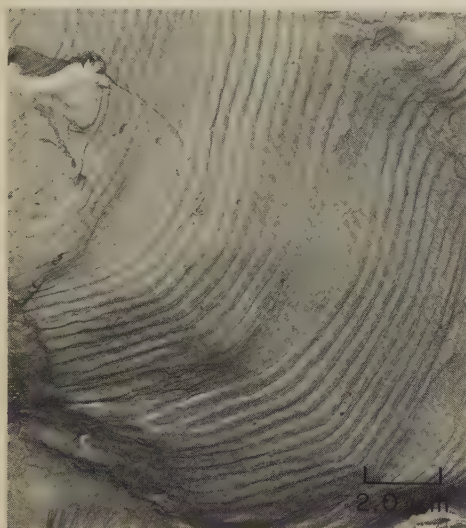
TEM fractograph (p-c replica) 4900×
Fig. 32. Effect of spectrum loading on fatigue-striation spacing in a laboratory test fracture in aluminum alloy 7075-T6

Under actual operating conditions, a propagating fatigue fracture is usually subjected to repeated loads of different magnitude. These "spectrum" loads (repeated sequences of different loads) are reflected in the fracture appearance by a variation in the fatigue-striation spacing in the plane and direction in which the crack is propagating, as seen in the laboratory test fracture in Fig. 32. Because the stress level influences striation spacing, many investigators have proposed quantitative relationships between striation spacing and cyclic-stress levels. By judicious use of striation-spacing measurements, it is possible to provide an estimate of the stress levels the fractured part may have been subjected to (Ref 8).

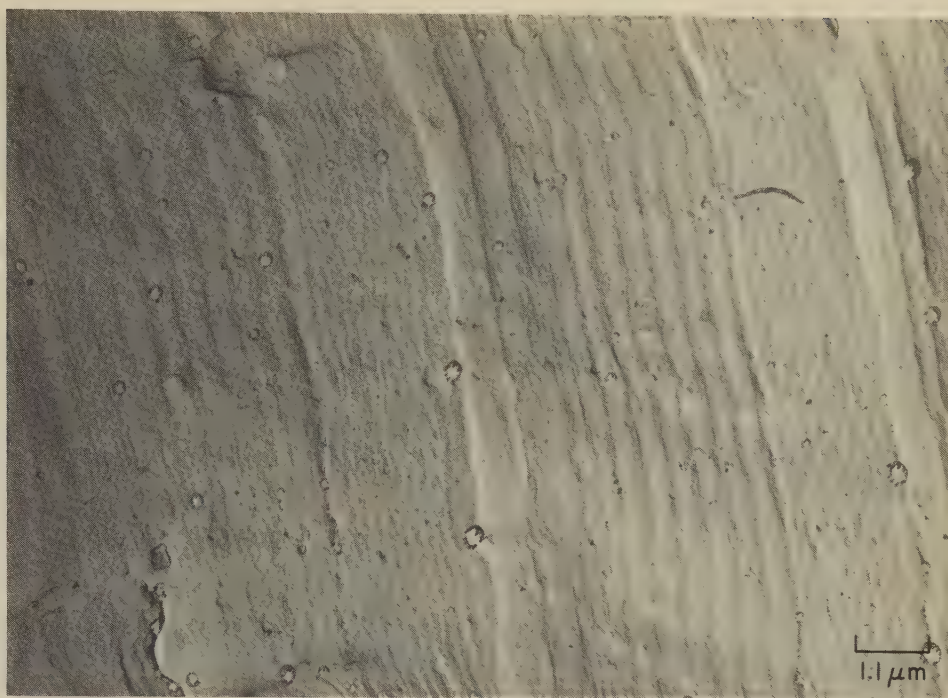
TEM fractograph (p-c replica) 8800×
Fig. 33. Surface of a fracture in aluminum alloy 7075-T6 showing the result of spectrum loading that was applied in ten-cycle blocks as follows: ten cycles at ± 77.6 MPa (± 11.25 ksi), and ten cycles at ± 17.2 MPa (± 2.5 ksi)

Often, spectrum fatigue loading can result in crack arrest. For example, if cyclic stress at high amplitude is followed by cyclic stress at low amplitude, there may be no evidence of striation formation for several cycles. In Fig. 33, it can be seen that a change from ten cycles of an alternating stress at ± 77.6 MPa (± 11.25 ksi) to ten cycles at ± 17.2 MPa (± 2.5 ksi) resulted in no striation formation for a brief initial period. Consequently, it is not always possible to count fatigue striations to determine the total number of cycles to which a part may have been sub-

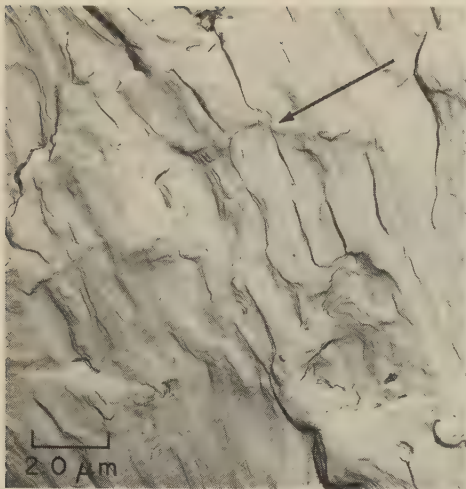
TEM fractograph (p-c replica) 4900×
Fig. 34. Fracture surface of titanium alloy Ti-6Al4V showing low-cycle fatigue striations (2350 cycles to fracture). Arrow indicates fracture direction.

Striations in low-cycle fatigue fractures* appear to be rather broad, widely spaced, and often discontinuous (Fig. 34 and 35). In many metals and alloys, especially in ultra-high-strength and low-strength materials, the striations may not be formed. In some metals, low-cycle fatigue fractures occur by a mechanism resembling microvoid coalescence (Ref 9) and show no evidence of striations.

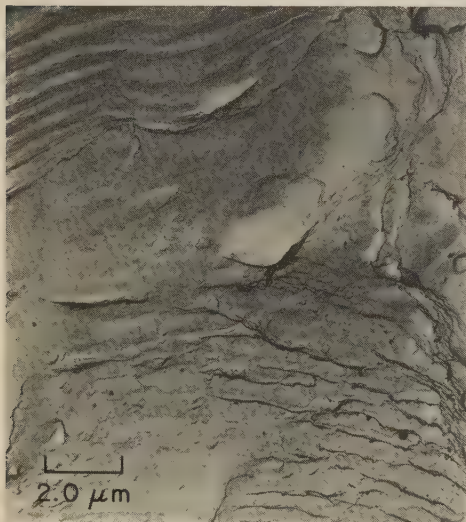
TEM fractograph (p-c replica) 4900×
Fig. 35. Fracture surface of aluminum alloy 7075-T6 showing well-formed low-cycle (700 cycles to fracture) fatigue striations at top left. Striations at bottom left are faint, perhaps have been rubbed. Those at right seem flattened to narrow grooves.

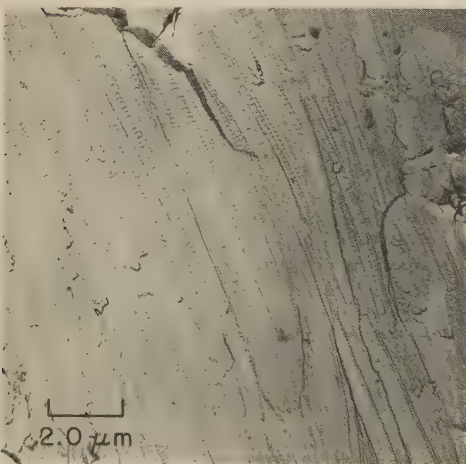
TEM fractograph (p-c replica) 4900×
Fig. 36. "Tire tracks" on a fatigue-fracture surface of aluminum alloy 6061-T6

A fracture feature associated with high-stress, low-cycle fatigue is known as "tire tracks" (Fig. 36). Tire tracks are most frequently observed on relatively steep slopes of the fracture surface. They are evidence of mechanical damage on the fracture surfaces caused by the repeated

impacting and relative motion of the two mating surfaces. Sometimes, tire tracks are caused by loose particles caught between the mating fracture surfaces. Tire tracks are not fatigue striations, but they are reliable indicators of fatigue fracture.

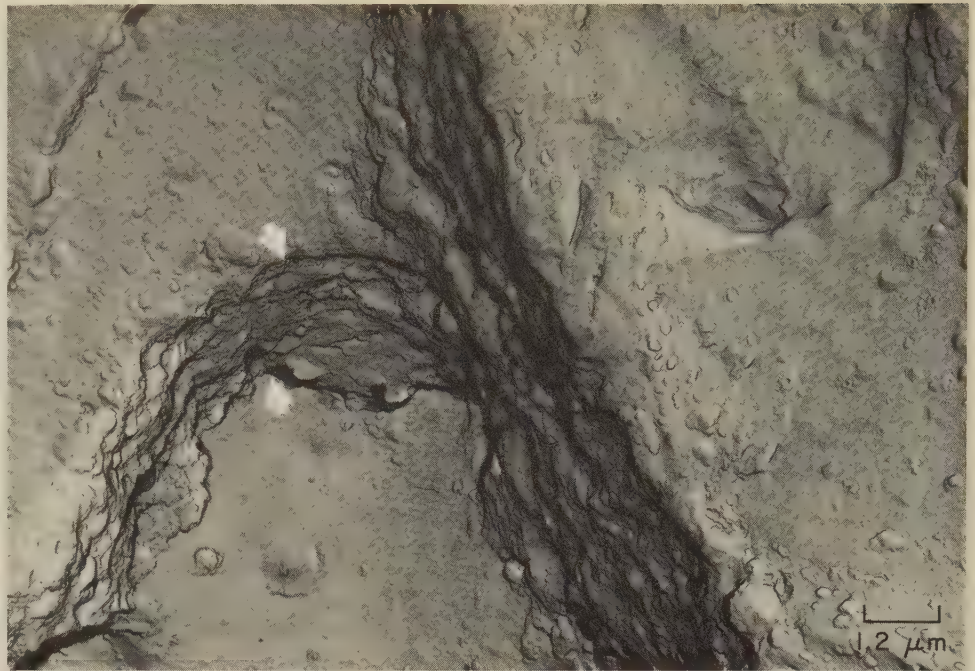
TEM fractograph (p-c replica) 8200×
Fig. 37. Surface of a fatigue fracture in aluminum alloy 2014-T6 showing dimples that formed between plateaus containing fatigue striations. The tensile tear (between arrows) connects two levels of crack propagation.

As a fatigue crack grows to near-critical size, bands of dimples can be seen between plateaus containing fatigue striations (Fig. 37). The appearance of both dimples and striations on the same fracture surface explains why the spacing of fatigue striations does not correlate well with macroscopic crack-growth rates (Ref 10 and Fig. 38), especially at higher crack-growth rates. The macroscopic crack-growth rate is the sum of the nor-

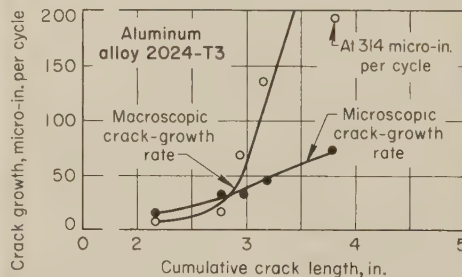
Fig. 38. Relation between microscopic and macroscopic crack-growth rates and cumulative crack length in fatigue fracture

Data were obtained on specimens of aluminum alloy 2024-T3, 0.050 in. thick, fatigue tested at a frequency of 1000 cycles per minute. Microscopic rate was determined by striation spacing. Macroscopic rate was estimated from observed crack growth in successive groups of stress pulses.

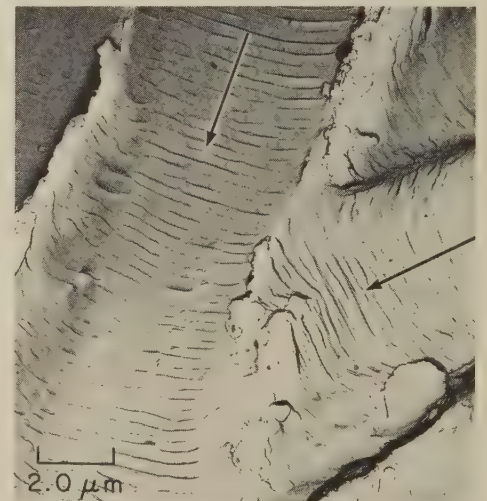
TEM fractograph (p-c replica) 4900×
Fig. 39. Striations on two joining, independent fatigue-crack fronts on a fracture surface of aluminum alloy 6061-T6. The two arrows indicate direction of local crack propagation.

Fatigue striations usually bow outward in the direction of local crack propagation. However, this feature cannot be depended on to denote the direction of macroscopic crack growth, because the fatigue striations on a single fracture surface can indicate crack growth in several different directions (Fig. 39 and 40).

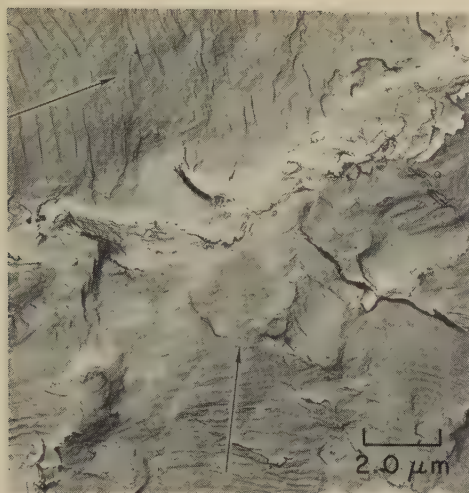
TEM fractograph (p-c replica) 4900×
Fig. 40. Extreme differences in local crack-propagation directions on a fatigue-fracture surface of titanium alloy Ti-6Al-4V, as indicated by the striations (and the arrows)

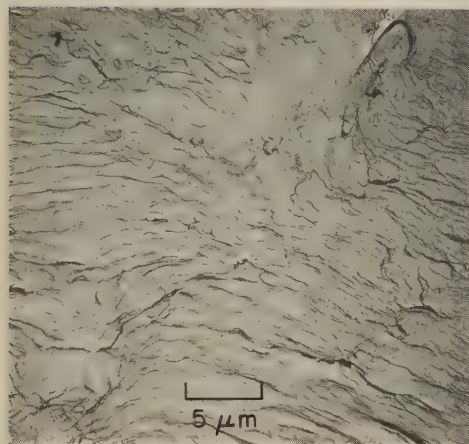
Fig. 41. Fatigue striations in a fracture surface of soft aluminum alloy 1100

TEM fractograph (p-c replica) 2000×
The poorly formed and very irregular fatigue striations here are typical of those on fracture surfaces of very soft metals. These are often difficult to interpret because of their deformed shapes.

Fatigue striations are best seen on fracture surfaces of alloys of moderate hardness. In general, the very soft metals, such as pure aluminum, yield fatigue fractures characterized by irregular, poorly formed striations (Fig. 41). Very hard metals, such as low-alloy steel at a tensile strength of 1795 to 1930 MPa (260 to 280 ksi), produce poorly formed striations, which are difficult to interpret (Fig. 42).

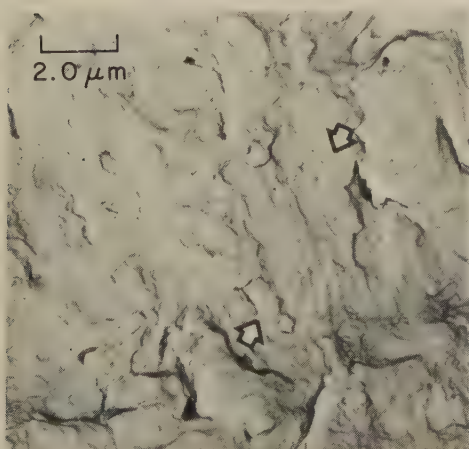
TEM fractograph (p-c replica) 4900×
Fig. 42. Poorly formed striations (between arrows) on a fatigue-fracture surface of D-6ac steel with a tensile strength of 1795 to 1930 MPa (260 to 280 ksi)

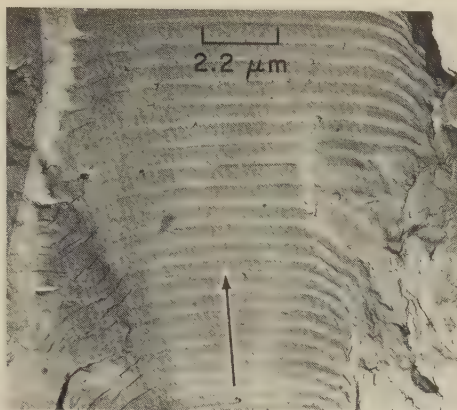
TEM fractograph (p-c replica) 4550×
Fig. 43. "Ductile" fatigue striations on a fracture surface of aluminum alloy 7079-T651. Arrow indicates fracture direction.

Occasionally, distinction is made between "ductile" and "brittle" striations observed on the surfaces of fatigue fractures in aluminum alloys. Ductile striations (Fig. 43) are more commonly observed than brittle striations (Fig. 44). In Fig. 45, note that the brittle striations appear to combine the features of cleavage (steps) and fatigue (striations that appear very flat). Generally, brittle striations can be attributed to the effect of an environmental factor acting at the crack
